CASE STORY

Flicker Mitigation and Power Quality Improvement at Van Merksteijn International

Van Merksteijn Int.

Almelo, The Netherlands

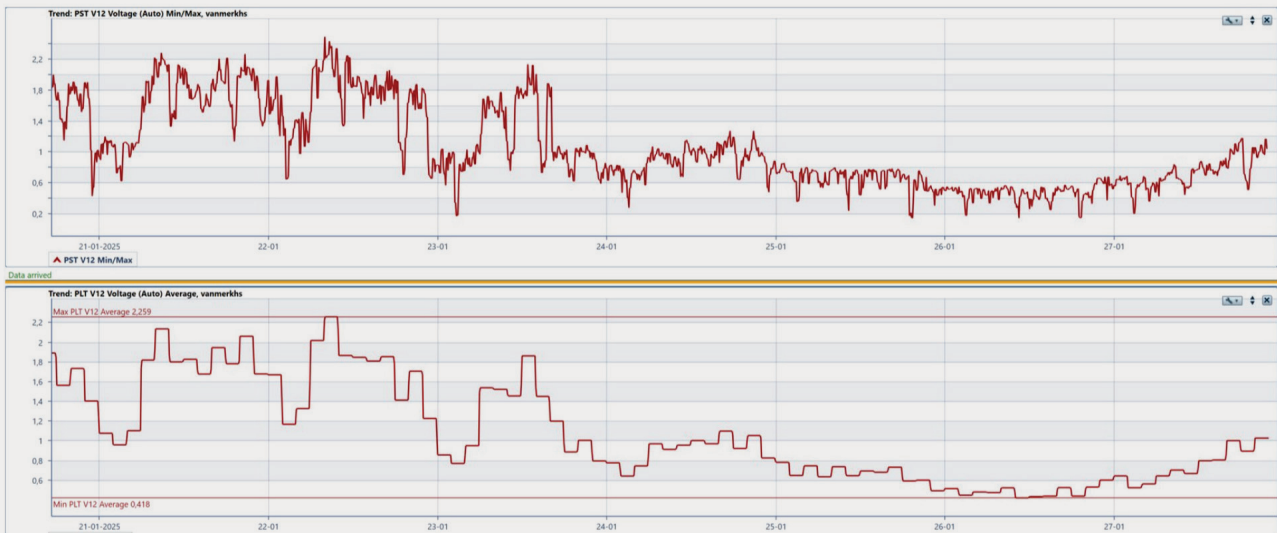
Post-installation trend data shows a clear reduction in flicker severity. Short-term flicker (Pst), which previously fluctuated at levels typically between approximately 1.5 and above 2.0, was reduced to a range generally below 1.0. Long-term flicker (Plt), previously observed around 1.5 to above 2.0, decreased to values typically between approximately 0.5 and 1.0, with minimum levels recorded near 0.4.

The measured compensation behavior confirms that the active flicker filters tracked load variations and injected an opposing current profile, reducing the impact of fluctuating loads on the electrical network. This resulted in improved power quality, reduced voltage fluctuations, and a more stable operating environment.

Prior to installation, measured flicker levels at the site were $Pst = 2.5$ and $Plt = 2.2$, exceeding acceptable limits defined by the grid owner.

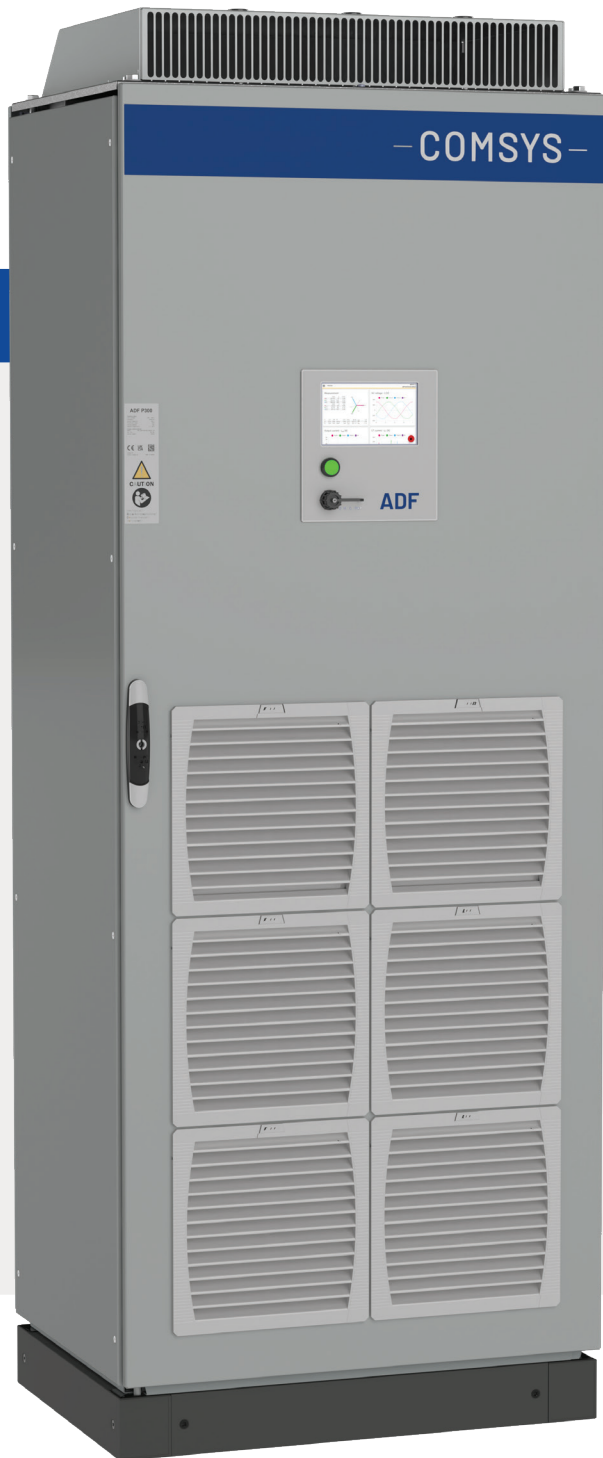
ADF P300

- » HARMONIC ELIMINATION
- » LOAD BALANCING
- » DYNAMIC VAR COMPENSATION
- » MODULAR & SCALABLE DESIGN
- » FLICKER COMPENSATION
- » 208-690V NOMINAL VOLTAGE
- » CLOSED LOOP, OPEN LOOP & SENSORLESS CONTROL
