## CASE STORY

# Improving power quality aboard M/Y Menorca with Comsys ADF

La Spezia, Italy

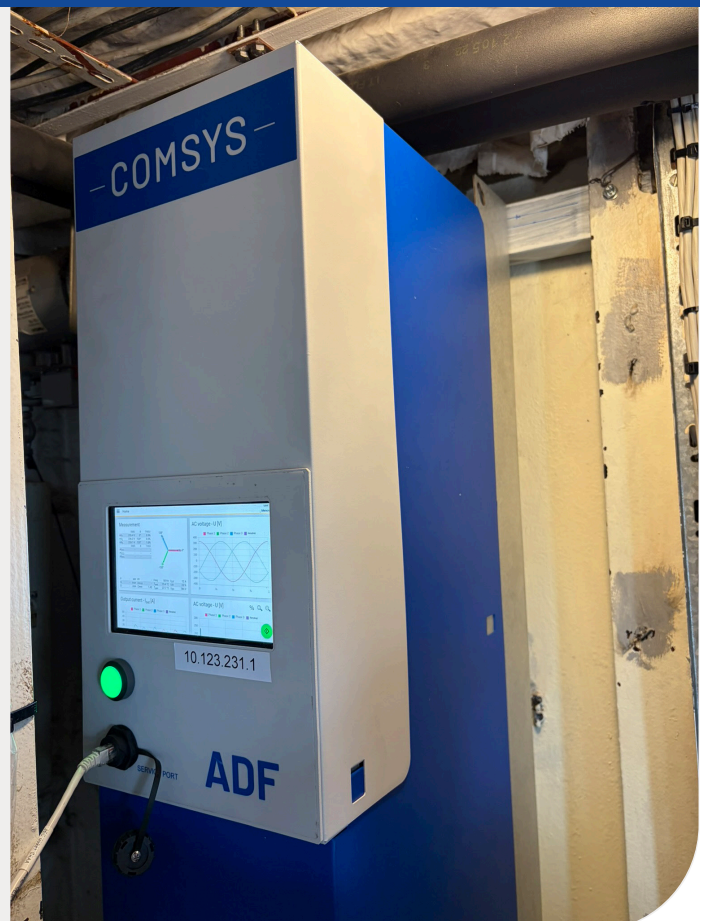
The unit was installed in the vessel's electrical network, where it injects controlled compensation currents to counteract harmonics. This compensation reduces voltage distortion in the supply to connected equipment.

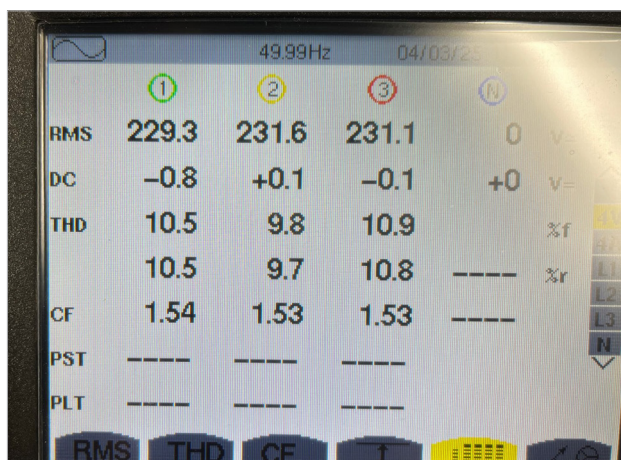
### Measurements before ADF installation

Measurements taken before installation recorded voltage total harmonic distortion (THDv) of 9.8-10.9% across the three phases. Current total harmonic distortion (THDi) measured 18.3-20.7%. Art.El. also reported electrical unbalance in the network.

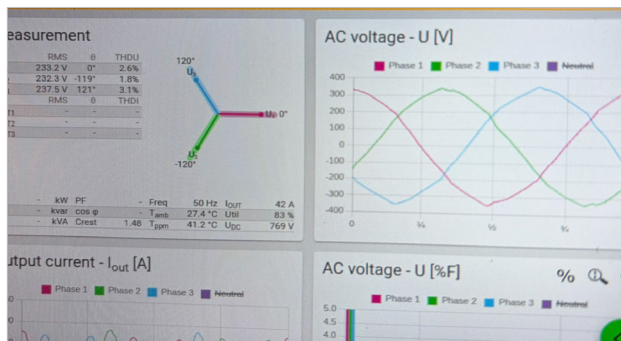
### Measurements with ADF ON

Following installation and commissioning of the Comsys ADF P100 G4, a clear improvement in power quality was observed. Voltage total harmonic distortion decreased from approximately 10% to around 2-3% with lower readings across all three phases, bringing levels within the applicable compliance limits.
